Missing Data – Digital Diagnostic Terminal Screen – 225

Mariner and Mercury

1994 225
S/N 0D280813 thru 0G051352
that had the original ECU replaced with P/N
824866—1 ECU

1994 225
S/N 0G051353 and above

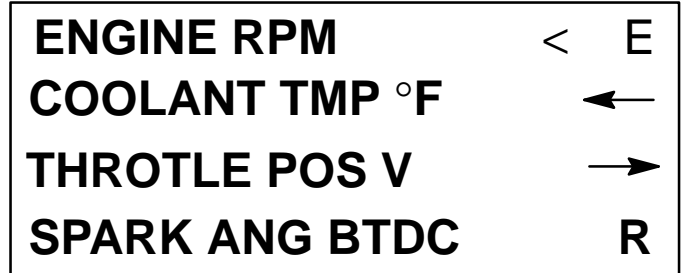
Figure 2. DDT Screen.

The Digital Diagnostic Terminal (DDT) may display a screen with no information (figure 2) when the unit is connected to the newer 824866—1 ECU (Quicksilver replacement p/n 824866A—1) even when the proper connections are made. This screen may appear when the ignition key is turned "ON" or the engine is started and running. This error is caused by the ECU not communicating with the DDT and the fix is easy.

To establish the proper communication with the ECU:

1. Disconnect the diagnostic harness from the ECU.
2. Reconnect the harness.
3. Data should appear.

The disconnect/reconnect must be done with the engine not running with the key "ON" or with the engine running.

The 1995 ECU will have improvements to eliminate the communication problem between the ECU and the DDT on initial start up.

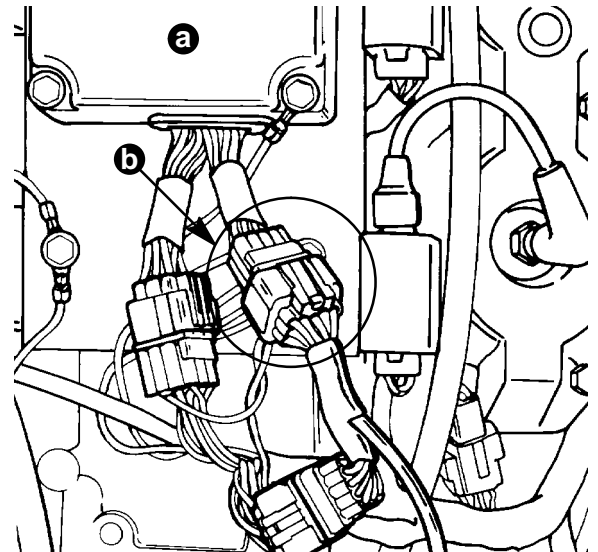
Figure 3. Connector Location.

- a - ECU
- b - Disconnect/Reconnect Diagnostic Harness.
