Missing Data – Digital Diagnostic Terminal Screen – 225

Mariner and Mercury

1994 225
S/N 0D280813 thru 0G051352
that had the original ECU replaced with P/N
824866—1 ECU

1994 225
S/N 0G051353 and above

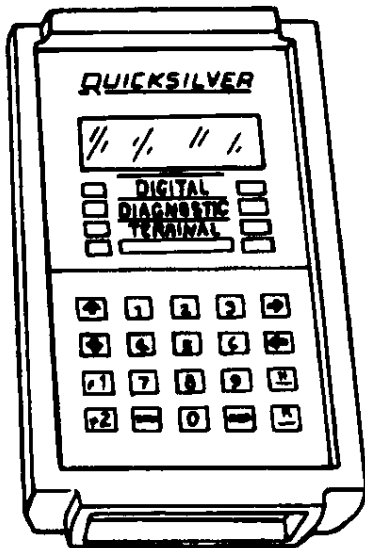
Figure 1. Digital Diagnostic Terminal (DDT).

The Digital Diagnostic Terminal (DDT) may display a screen with no information (figure 2) when the unit is connected to the newer 824866—1 ECU (Quicksilver replacement p/n 824866A—1) even when the proper connections are made. This screen may appear when the ignition key is turned "ON" or the engine is started and running. This error is caused by the ECU not communicating with the DDT and the fix is easy.

CORRECTION:

To establish the proper communication with the ECU:

1. Disconnect the diagnostic harness from the ECU.
2. Reconnect the harness.
3. Data should appear.

The disconnect/reconnect must be done with the engine not running with the key "ON" or with the engine running.
