## High-Pressure Hydraulic Hose Length Causing Intermittent Pressure Fault

Models Covered	Cummins Serial Number
All CMD/Mercury QSD 2.8L Generation 1 Diesel Axius Products All CMD/Mercury QSD 4.2L Generation 1 Diesel Axius Products	88401303 and above

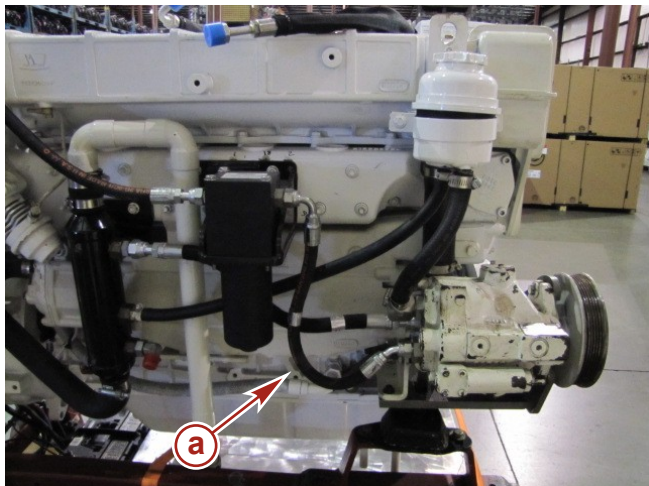
### Incorrect Hose

The power steering high-pressure hose, Mercury Marine part number 32-8M2019262, installed between the Axius power steering pump and the Axius high-pressure filter, can increase resonance in pump output pressure. This resonance may result in intermittent pump output pressure faults and alarms. The length of the hose is the primary cause of the resonance.

The high-pressure hose, part number 32-8M2019262 measures 38.1 cm (15 in.) end to end (seating surface to seating surface).

- a -** Requires part number 32-8M0065248 to be ordered and installed

Order and replace with high-pressure hose kit, part number 32-8M0065248.

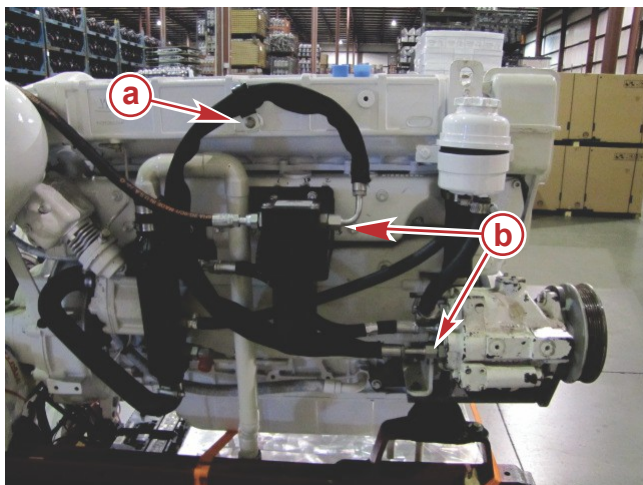
### Correct Hose Routing

- a -** Hose clamp and bolts  
**b -** Hose swivel fittings

Description	Nm	lb-in.	lb-ft
Bolts (M8 x 12)	19		14
Hose swivel fittings	27		20
