Service Bulletin

Bulletin No. 2012-65R1
Circulate to:	Sales Manager	Accounting	Service Manager	Technician	Parts Manager

3000 Series Zeus Pods Product Improvements

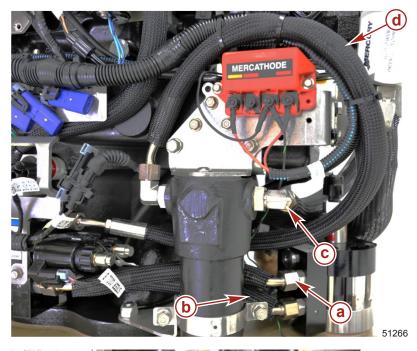
- a 8M0053639 from steering manifold port
 A to upper port on trim manifold
- **b** 8M0053640 from steering manifold port B to lower port on trim manifold
- c 8M0053638 hydraulic pump to high pressure filter
- **d** 8M0053637 high pressure filter to steering manifold

Use the following chart for the part numbers of each hose. Replace all four high-pressure steering and trim tab hoses if any pod is found to have leaking hoses, along with the hoses on all pods on the vessel.

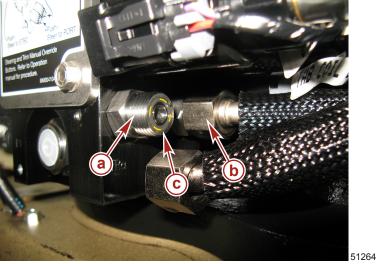
- a Port A on steering manifold
- **b** Port B on steering manifold
- Verify o-ring remains intact in fitting before installation of new hose

NOTE: Ensure that the hose fitting and area around the fitting is clean before removal to avoid contamination. Use only a lint-free cloth to clean the fitting area before removal. Keep the replacement hoses sealed in the shipping bag until the time of installation. Refer to Service Manual #52, Section 5C, for complete instructions on replacing hoses.

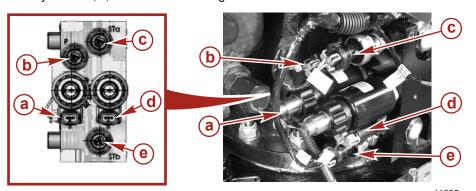
Each pod's hydraulic steering manifold contains three (3) pressure transducers. These steering pressure transducers are indicated by letters b, c, and e in the following illustration.

- a Trim tab coil A (TCA)
- **b** Pump pressure sensor
- c Steering A pressure sensor
- d Steering coil A (SCA)
- e Steering B pressure sensor

If the inspection reveals that the pressure transducers have already been changed to the new sensor shown in Figure B above, it is not necessary to replace them. If the inspection reveals the pressure transducers for the steering and trim tab systems have not been replaced and are identified as the transducer shown in Figure A above, replace each of the transducers on each pod. JH Zeus applications will need five total transducers for steering and trim tab hydraulic systems.

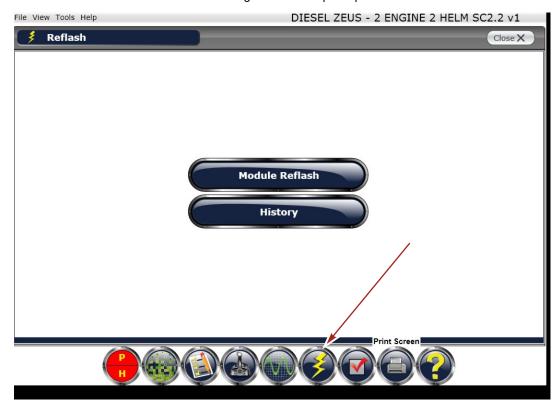
50544

Select Reflash then select Module Reflash to begin the reflash prerequisites.

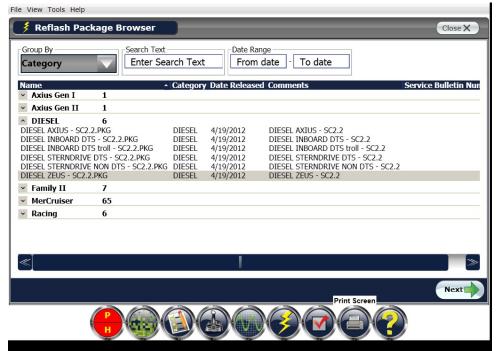
50597

Select the Diesel category, then select the DIESEL ZEUS - SC2.2.PKG download for update to proceed.

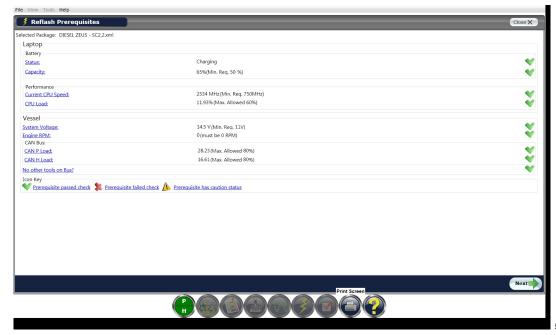
50545

- The system will check prerequisites of both the laptop PC and the Zeus system that must be passed before CDS G3 will
 allow reflash to proceed. If there are any cautions or failed checks listed, those must be addressed before proceeding.
 - Make sure the laptop is connected to an AC 110 volt source to prevent module damage due to discharge of laptop battery that can occur during reflash.
 - During Module Reflash the system may launch the prerequisite screen again prior to letting you proceed with a
 particular module to ensure that all items are still showing passed checks.
- If all checks show passing indication, select Next.

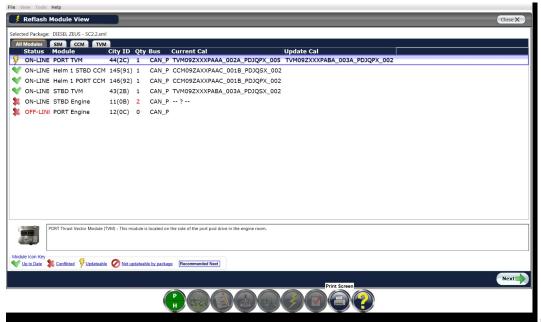
50574

• As each SIM is flashed, the number of modules that appear on the starboard City ID (11 decimal, 0BHex) will increase by one. As the quantity of the starboard SIMs goes from 1 to 2, note that the display will show a "conflicted" red x icon next to the modules that have been completed. This is normal and expected.

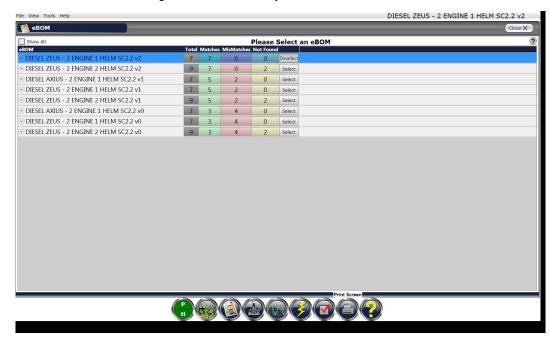
50543

Ensure the Select indication changes to Deselect after you click on it.

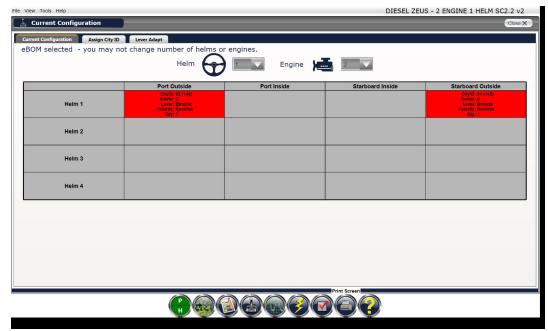
50547

- Go to Configuration, then select Helm Configuration, then choose Helm Setup.
- Assign City ID's using the tab marked Assign City ID.
- Follow the onscreen directions to complete the City ID assignment.
- Upon completion, all CCM modules are assigned a unique City ID.
 - · Each module City ID corresponds to its helm and engine.

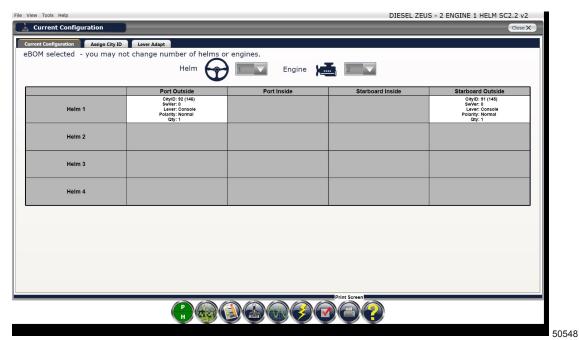
- Select the tab marked Lever Adapt, choose the correct remote control type and follow onscreen directions to completion.
- Do the lever adapt process for each helm separately.
- Upon completion:
 - Go back to the Current Configuration tab and ensure that all CCMs report their location correctly and show white status vs. red.

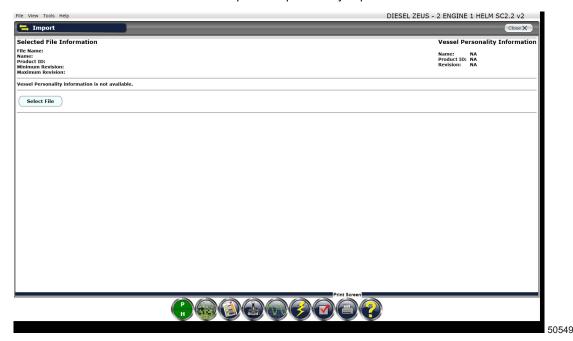
Follow the onscreen directions in CDS G3 to complete the personality import.

Use Select File to query the memory stick or file folder that contains the vessel personality.

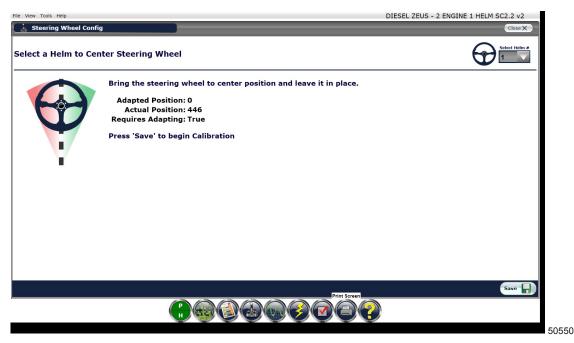
After a CCM is reflashed the memorized position of the steering wheel at center is lost. It must be reprogrammed using CDS G3. Go to **Configuration** and select **Helm Configuration**. Now select **Steering Wheel Config.** Follow the onscreen direction in the CDS G3 directions to reset the center position of the steering wheel. You must complete this for each helm separately.

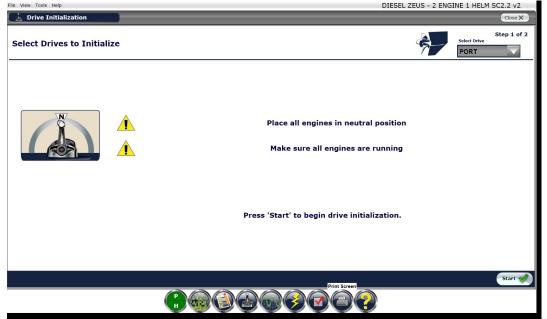
50551

Mechanical stop information must be restored using the **Drive Initialization** procedure. Go to **Configuration** and select **Drive Configuration** in CDS G3. Now select **Drive Initialization** and follow the onscreen directions to complete initialization of each pod's drive.

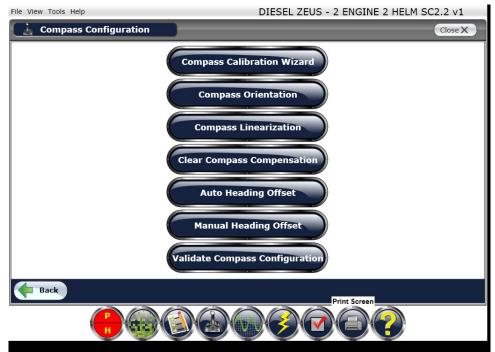
50553

Compass calibration procedure should also be performed during the water test if the IMU has been replaced. Only use the
Compass Calibration Wizard in CDS G3 to complete the compass calibration. Go to Configuration and select Compass
Configuration. Now select Compass Calibration Wizard and follow the onscreen directions to complete Compass
Calibration Wizard.
